**AFRL-VA-WP-TR-2004-3057**

**EFFECT OF PREEXISTING  
CORROSION ON FATIGUE CRACKING  
OF ALUMINUM ALLOYS 2024-T3 AND  
7075-T6**

**Final Report for 01 February 1993 – 01 August 1995**

**AIR VEHICLES DIRECTORATE  
AIR FORCE MATERIEL COMMAND  
AIR FORCE RESEARCH LABORATORY  
WRIGHT-PATTERSON AIR FORCE BASE, OH 45433-7542**

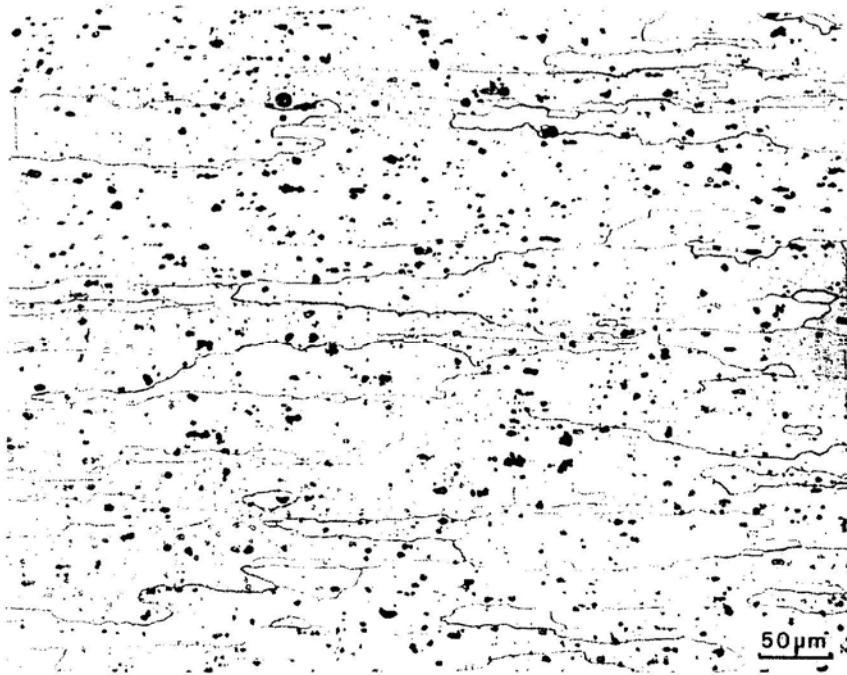
**Figure 2. Optical Micrograph of Cross Section through Aluminum Alloy 2024-T3 Showing Elongated Grains and Constituent Particles**

Corrosion in aircraft aluminum alloys occurs in several different forms.<sup>2-3</sup> Pitting and crevice corrosion are most common in the 2000- and 7000-series aluminum alloys which are the principal materials of construction. Pitting corrosion is a form of localized corrosion that occurs on exposed surfaces of passive metals under relatively stagnant conditions. Pitting may also occur on relatively film free metals at local metallurgical imperfections such as inclusions or constituent particles.<sup>4</sup> Although the mechanism of pit nucleation is not well understood, there is some evidence in aluminum alloys, that constituent particles act as nucleation sites. Wei and coworkers<sup>5</sup> have demonstrated that in 2000-series alloys, pitting nucleates at Al-Cu-Mg- and Al-Cu-Mn-Fe- containing particles, with the former particles acting as anodic sites, and the latter as cathodic sites. Figure 2 shows a typical microstructure of aluminum alloy 2024-T3 showing the elongated grains with a significant number of constituent particles.

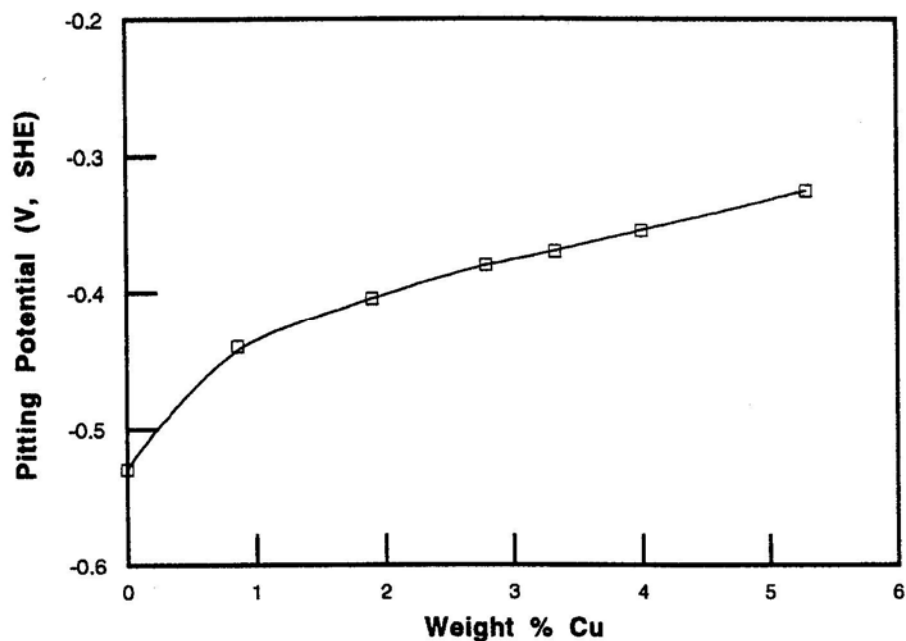
**Figure 3. Effect of Cu Content on Pitting Potential of Al-Cu Alloys. Mean Pitting Potentials Measured For Solution Treated Alloys In Deaerated 1M NaCl at 25 °C<sup>6</sup>**

Particularly, the copper containing particles have a detrimental effect on the pitting behavior of these aluminum alloys. The detrimental effect of copper in aluminum alloys is illustrated in Figure 3 which shows an increase in pitting potential as a function of copper concentration in Al-Cu alloys.<sup>6</sup>

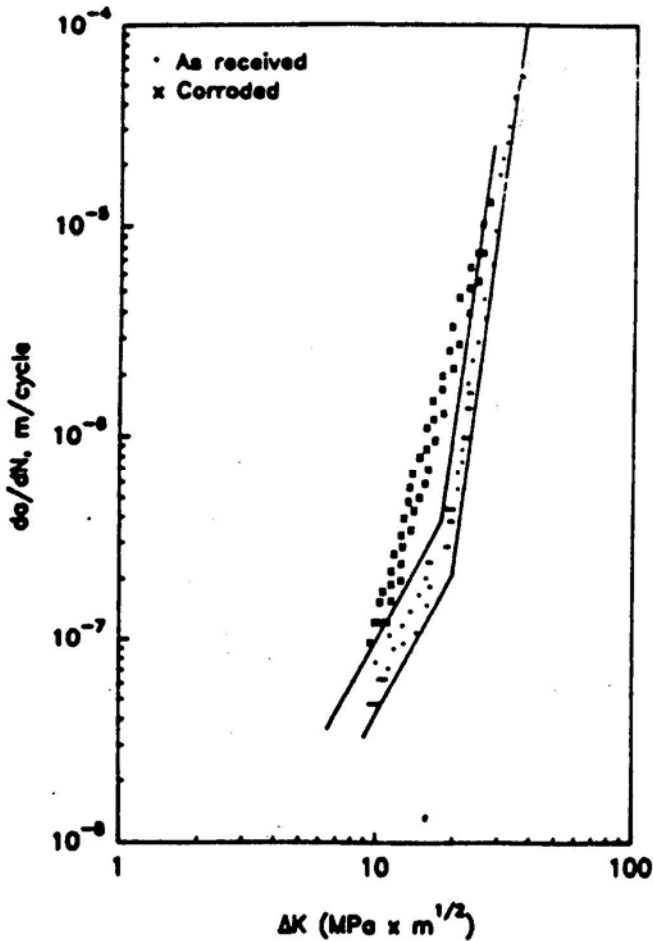
**Figure 4. Fatigue Crack Growth Data for Corroded 7178-T6 Compared with As-Received 7178-T6 Tested in Dry Air**

Work by Person,<sup>19</sup> and by Abramovici and coworkers<sup>20</sup> showed that pitting corrosion in aluminum alloys greatly reduced their fatigue life. This observation was confirmed by Smith and Duquette,<sup>20,22</sup> who found that precorrosion of 7075-T6 test panels greatly reduced their fatigue life. Chubb and coworkers<sup>21</sup> studied the crack propagation behavior of 2000- and 7000-series aluminum alloys through areas with exfoliation corrosion and found that fatigue cracks propagating in the 7000-series alloys accelerated considerably when they reached the exfoliated areas, see Figure 4.

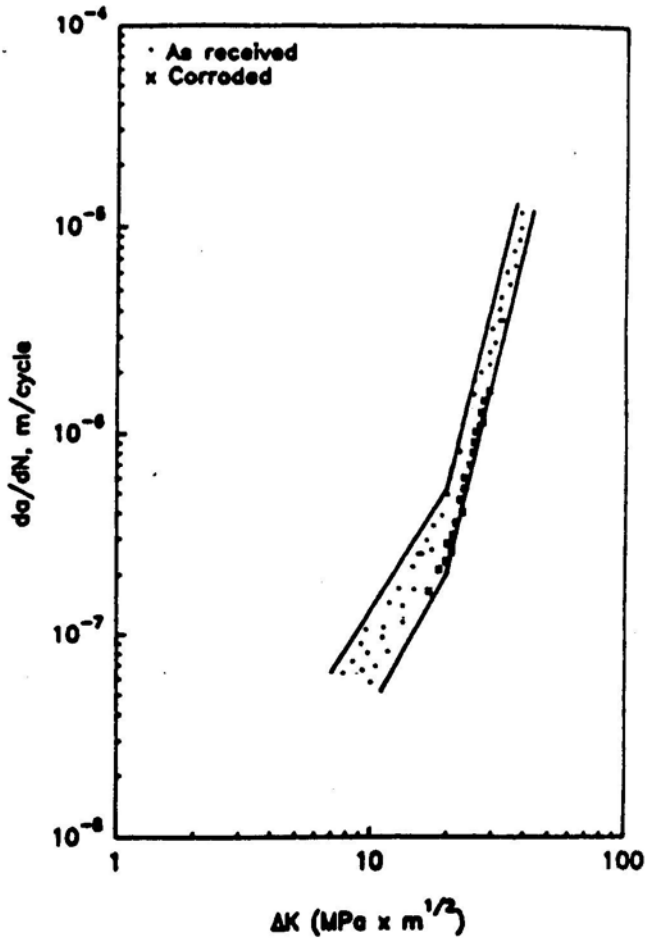
**Figure 5. Fatigue Crack Growth Data for Corroded 2024-T351 Compared with As-Received 2024-T351 Tested in Dry Air**

However, Figure 5 shows that, in the 2000-series alloys, no noticeable effect of corrosion on fatigue crack propagation was found. It should be noted that the test panels were made from actual aircraft skin corroded in service and that in the calculation of  $\Delta K$ , no correction was made for the loss in thickness due to corrosion. Smith and coworkers<sup>22</sup> produced multisite fatigue damage initiation and subsequent fatigue cracking in aluminum alloy 2024-T3 and 7075-T6 specimens with a collinear array of open fastener holes. They found that corrosion greatly decreased the fatigue life of the test panels and also observed faster growth rates in the corroded specimens.

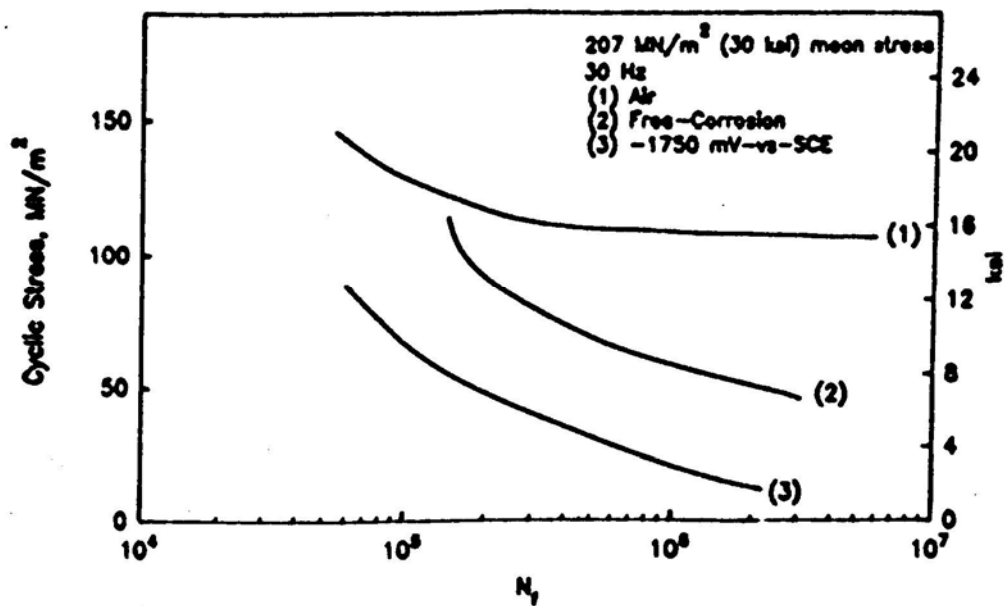
Figure 6. Fatigue Behavior of Al - 5.5 Zn - 2.5 Mg - 1.5 Cu in 0.5 M NaCl at Room Temperature Cathodically Polarized to -1750 mV Versus SCE Compared to Fatigue Behavior in Air and under Free Corrosion Conditions in 0.5 M NaCl

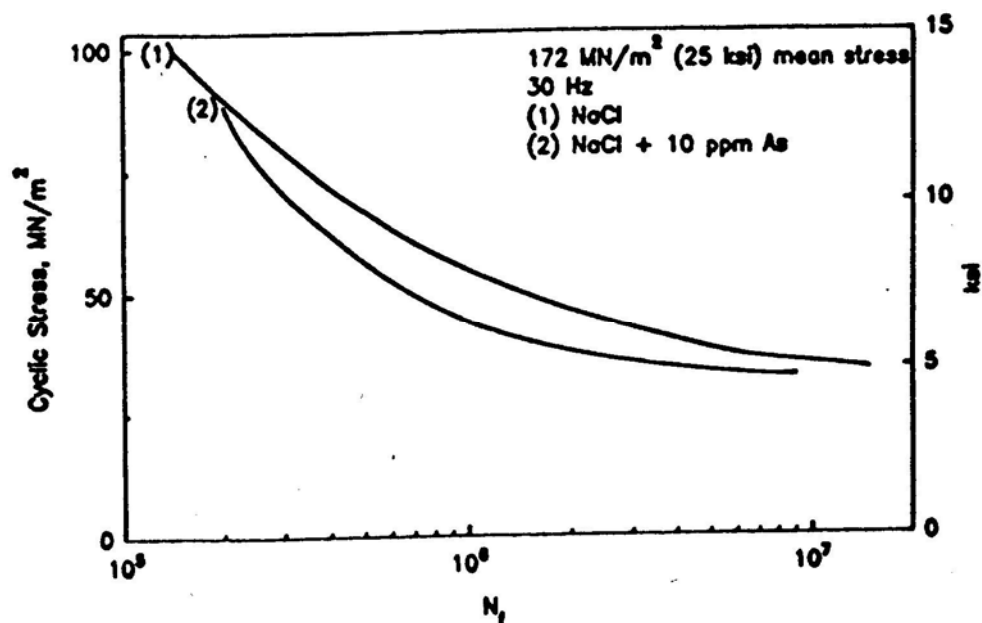
Figure 7. Fatigue Behavior of 7075-T6 in 0.5N NaCl + 10 ppm Arsenic (As) Compared to Fatigue Behavior under Free Corrosion Conditions in 0.5N NaCl

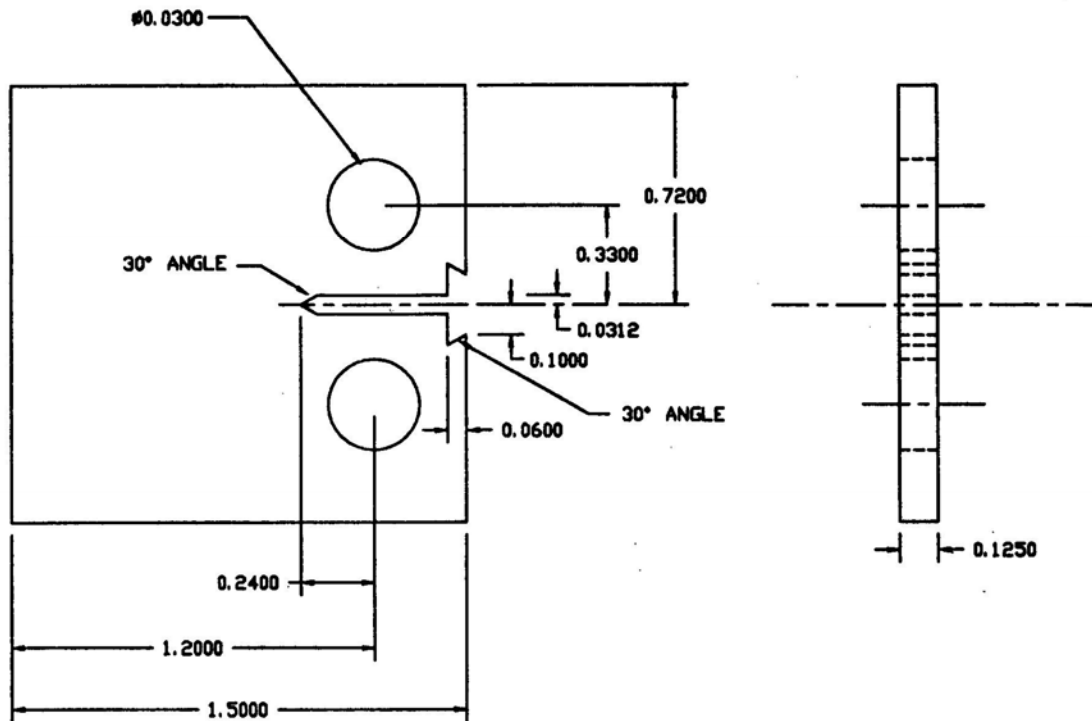
**Figure 8. Schematic Drawing of Standard ASTM Compact Tension Specimen**

For this task two types of specimens were used, namely a compact tension (CT) specimen and a modified CT specimen. The CT specimen, shown in Figure 8 was designed according to ASTM Standard E 647.<sup>31</sup> As indicated in the figure, the CT specimens were machined into 1.5 by 1.44 by 0.125 inch (38.1 by 36.6 by 3.2 mm) coupons. The width of the specimen was oriented in the longitudinal (L) direction of the sheet, and the crack was oriented in the T-L direction.

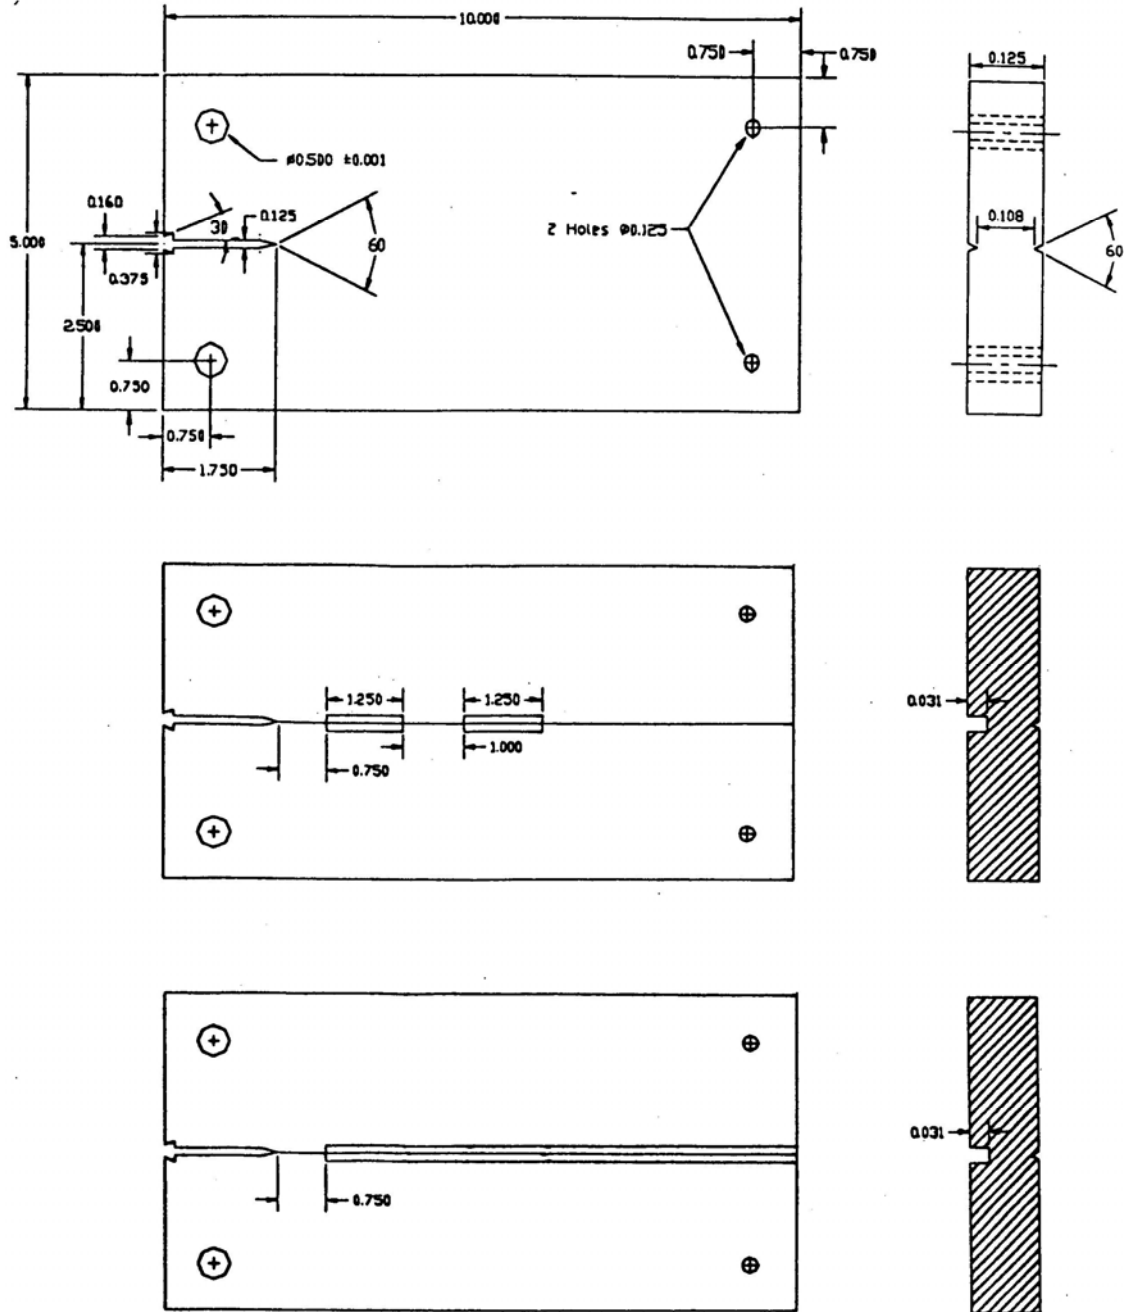
**Figure 9. Schematic Drawing of Modified Compact Tension Specimens**

Unfortunately, data from crack opening displacement (COD) tests for the modified CT specimens shown in Figure 9 could not be used to accurately infer crack length; therefore, crack growth data from modified CT specimens were not used to study the effect of precorrosion on crack growth rate (da/dN).

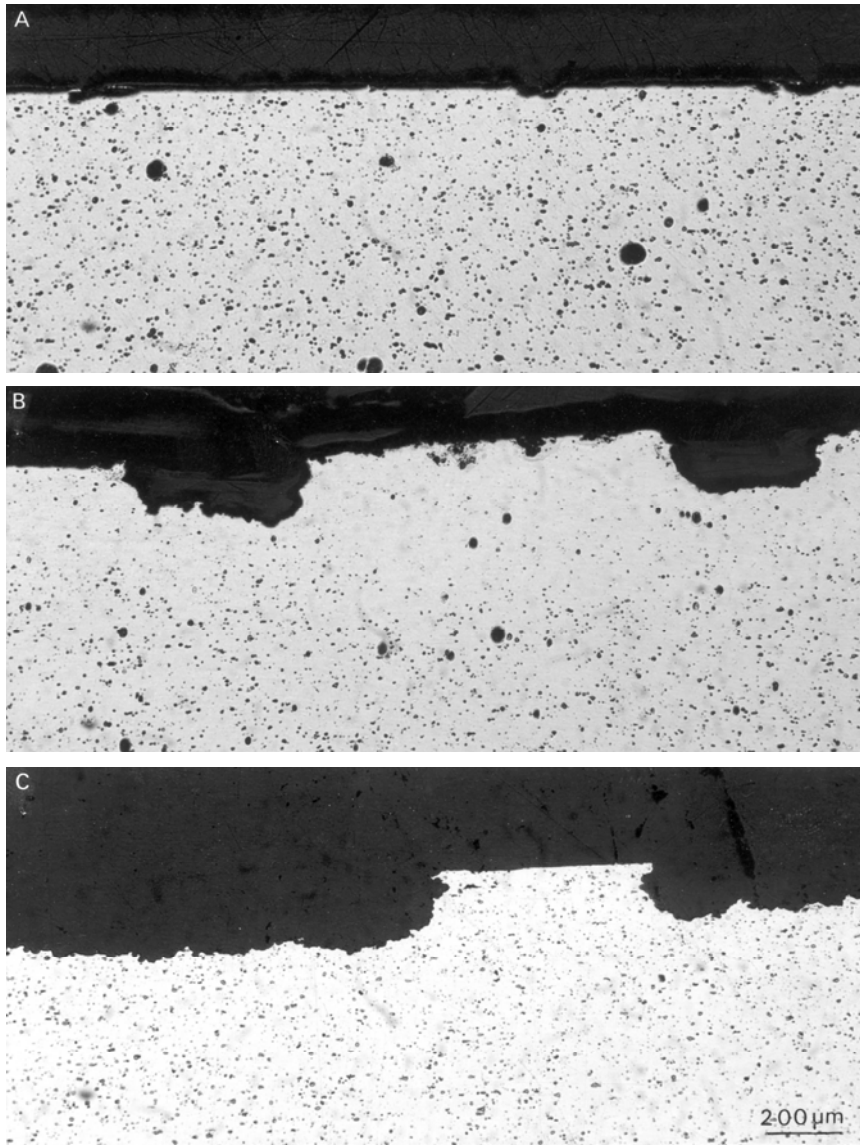
**Figure 12. Optical Micrographs of Metallographic Cross Sections of Aluminum Alloy 2024-T3, Exposed to the CASS Environment, Showing Different Stages in Pitting**

Although pitting was initially observed as localized breakdown events in both aluminum alloys 2024-T3 and 7075-T6, propagation of pitting was found to be different for each of these alloys. In the case of aluminum alloy 2024-T3, corrosion pits spread out over the surface, then grew in depth. After a relatively short period of time, the pits started to coalesce, and new pits formed at the bottom of the initial pits. Optical micrographs, shown in Figure 12 demonstrate that the initial pitting occurred within the grains, and that as corrosion progressed, smaller pits formed inside the wide pits. Some intergranular attack also was observed.

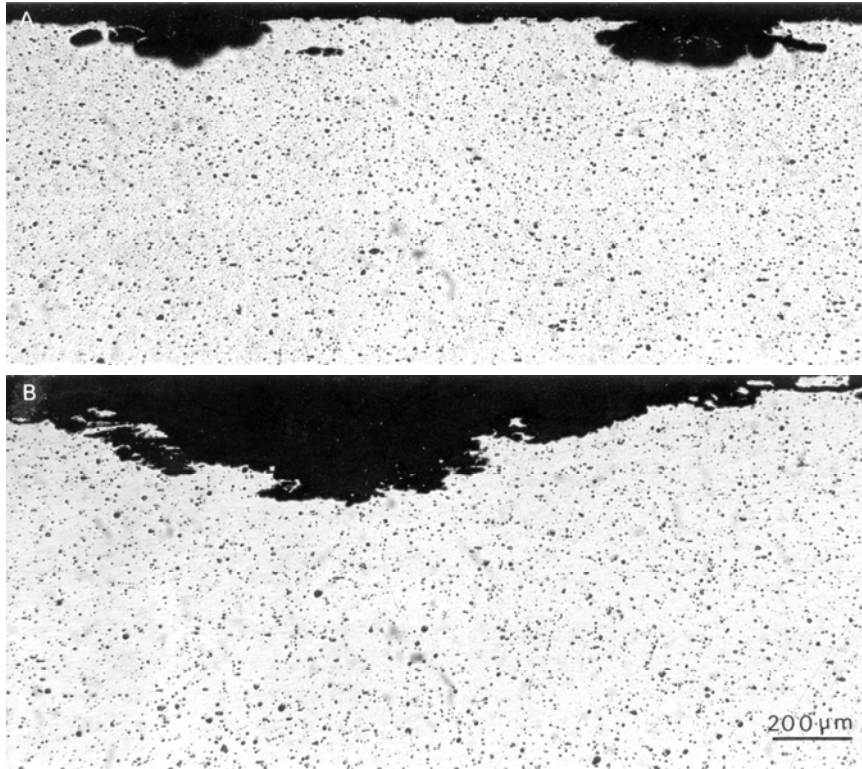
**Figure 13. Optical Micrographs of Metallographic Cross Sections of Aluminum Alloy 7075-T6, Exposed to the CASS Environment, Showing Different Stages in Corrosion Attacks: a) 3 Days and b) 14 Days of Exposure**

In the case of aluminum alloy 7075-T6, the initial pit morphology was in the form of small blisters, which are in fact layers of grains lifted off the surface. Following the initial attack, corrosion continued to occur preferentially along the grain boundaries, see Figure 13. Again, as in the case of alloy 2024-T3, the corrosion tended to spread over the surface, before it propagated into the sheet.

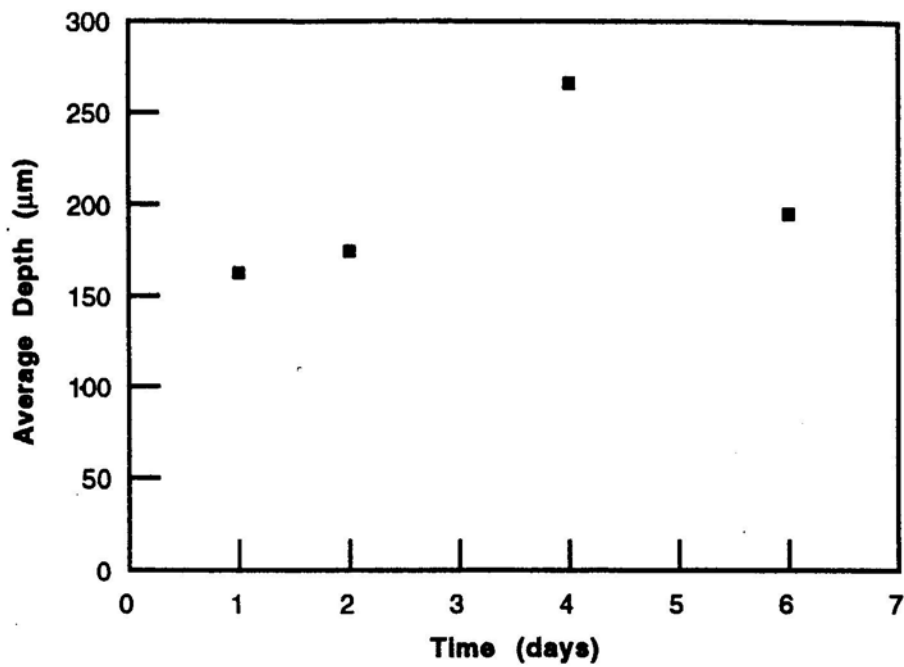
Figure 19. Exfoliation Depth of Aluminum Alloy 2024-T3 Exposed to the ASTM G34 EXCO Solution

For each test coupon, the average of the five deepest exfoliation penetrations was determined and plotted as a function of time, see Figures 19 and 20.

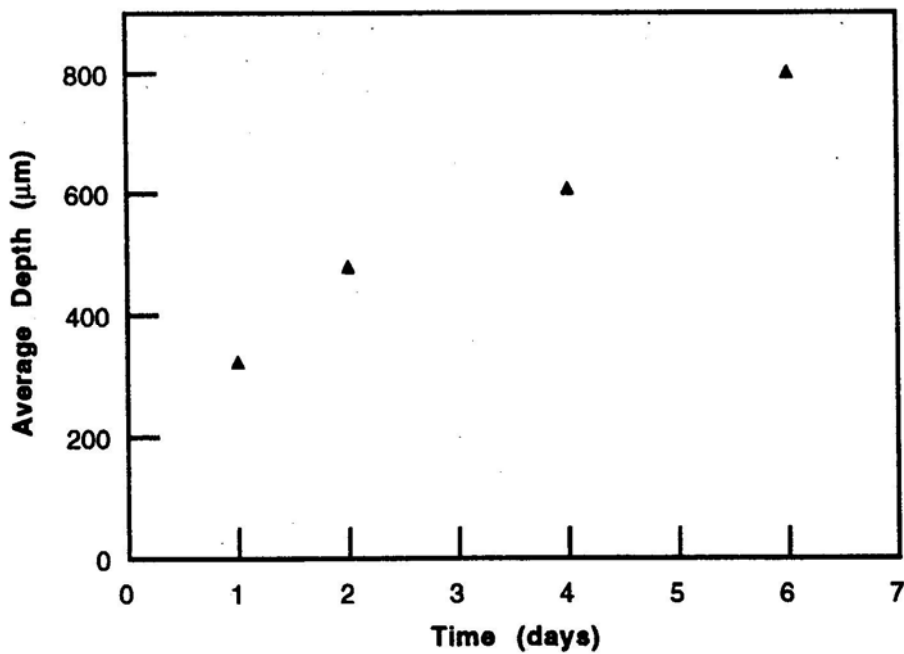
Figure 20. Exfoliation Depth of Aluminum Alloy 7075-T6 as a Function of Exposure Time in the ASTM G34 EXCO Solution

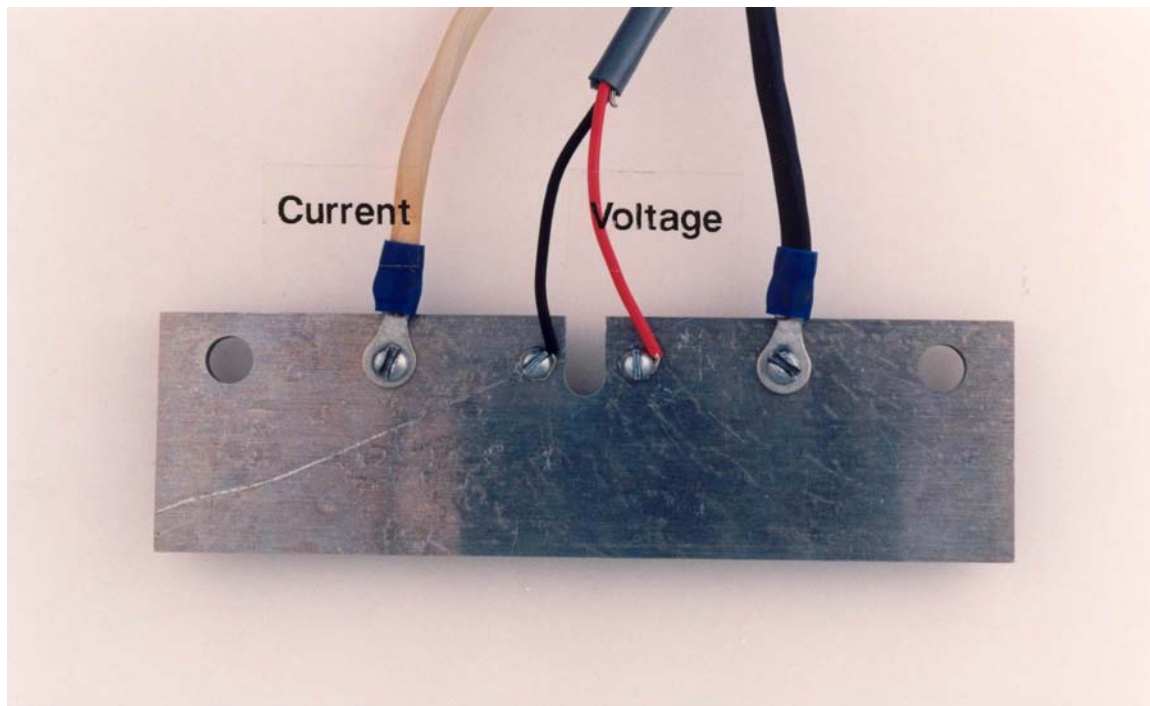
Figure 22. Photograph of ECT Specimen with Current and Voltage Leads Attached

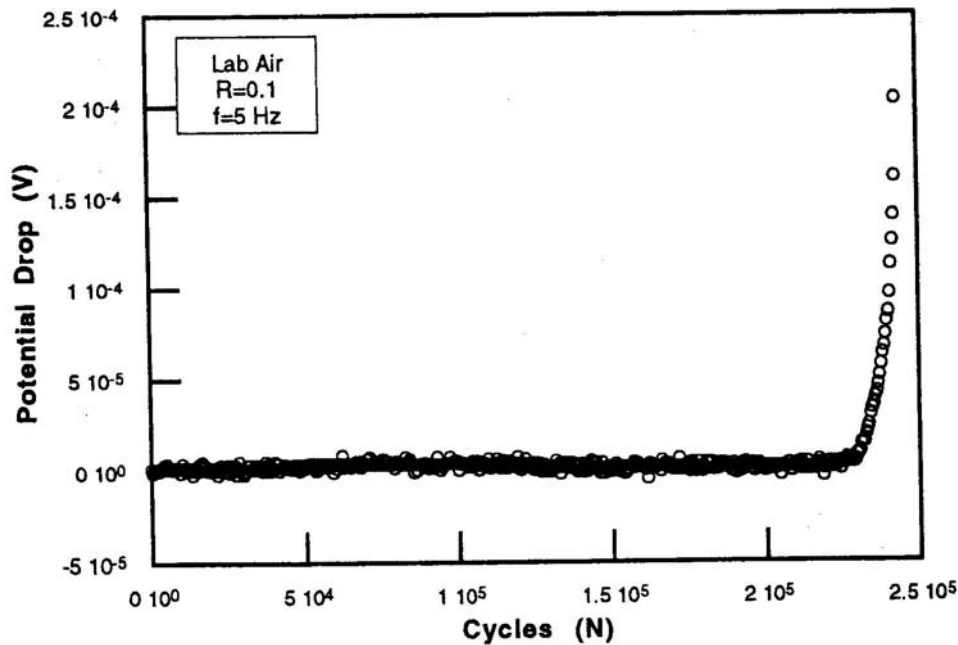
**Figure 24. Diagram of dc Potential Drop as a Function of Fatigue Cycles in Aluminum Alloy 7075-T6**

For each pretreatment, a test matrix was established with maximum loads of 250, 350, 450, and 550 pounds (1112, 1557, 2002, 2446N), or 1.7, 2.3, 3, and 3.7 ksi, (11.72, 15.85, 20.69, and 25.51 MPa), respectively. The ECT specimens were tested in laboratory air using a sinewave loading with an R ratio of 0.1. The test frequency was 5 Hz. The dc electric potential drop method was used to measure the crack length. Current and voltage leads were attached to the specimen, as indicated in Figure 22, to measure the electrical potential drop. The measurements were recorded on an external data acquisition system which was synchronized with the servohydraulic machine data acquisition. At the conclusion of the test, the two data files were merged into one spreadsheet. These diagrams were used to define the cycles to fatigue crack initiation, where the curve deviates from the constant horizontal line. Representative plots of fatigue cycles versus potential drop are shown in Figures 23 and 24.

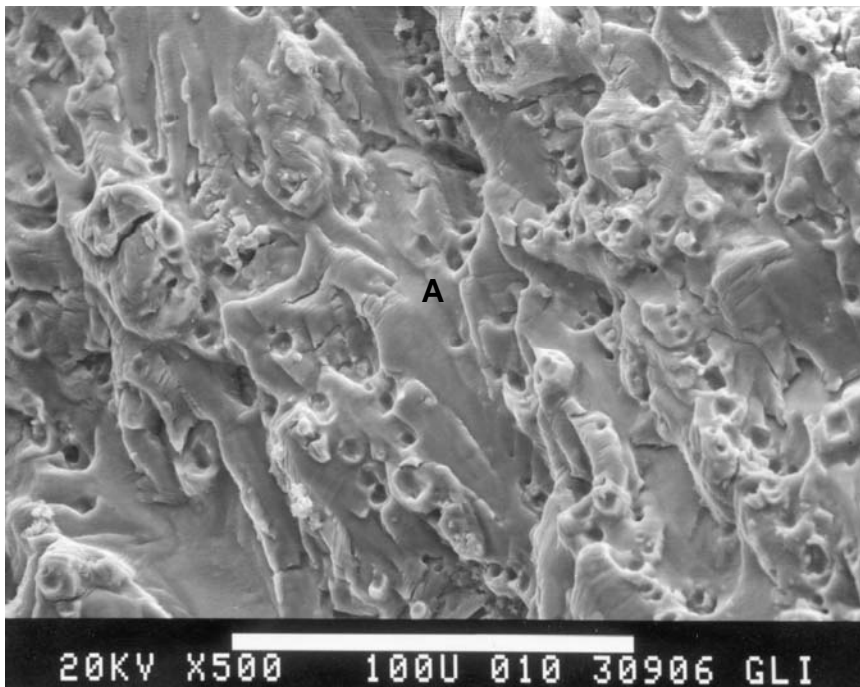
**Figure 29. SEM of Fracture Surface of Aluminum Alloy 2024-T3 Fatigued in Laboratory Air (1 Hz, R=0.1)**

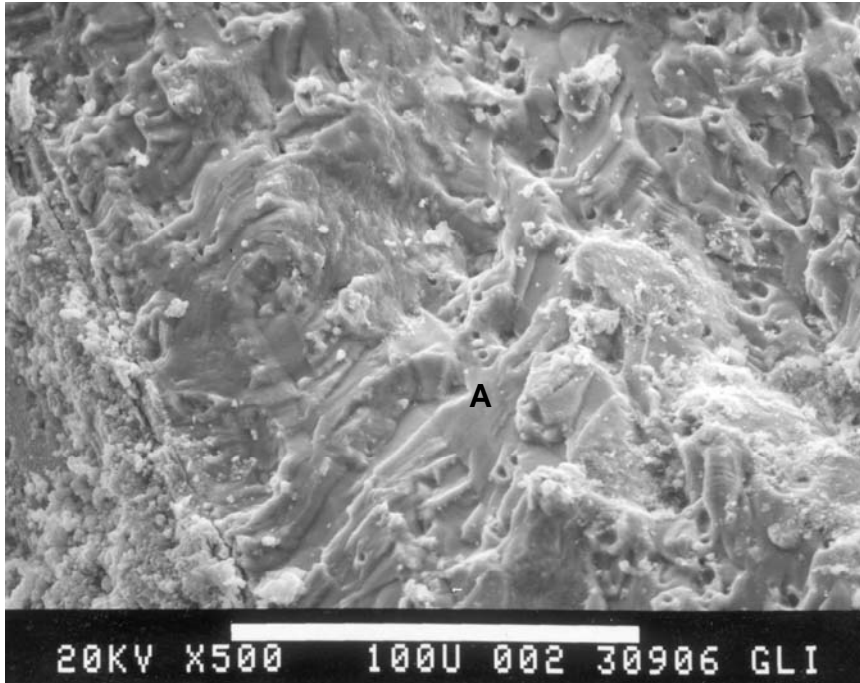
**Figure 31. SEM of Fracture Surface of Aluminum Alloy 2024-T3 Precorroded in the CASS Environment and Fatigued in Laboratory Air (1 Hz, R=0.1)**

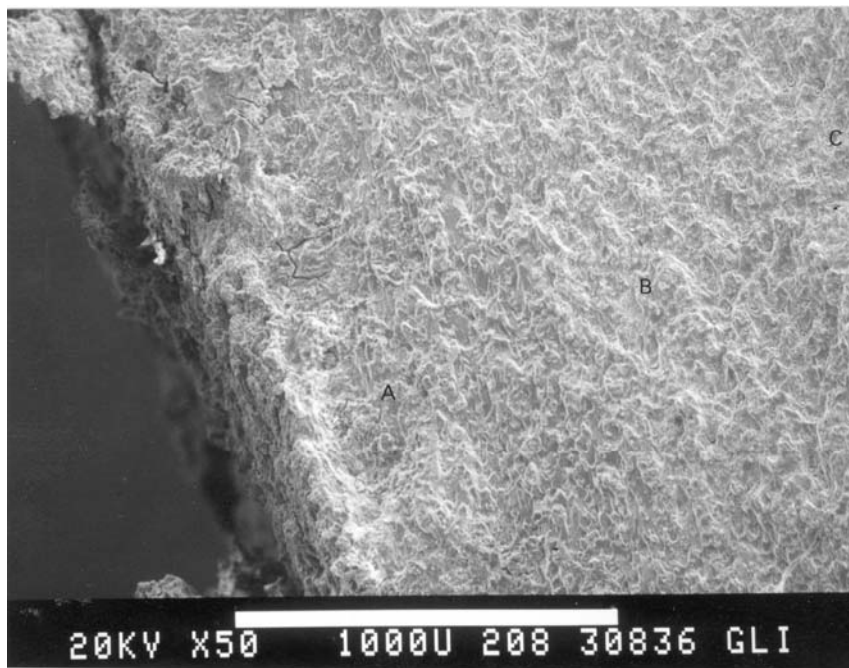
**Figure 35. SEM of Fracture Surface of Aluminum Alloy 2024-T3 Precorroded in the EXCO Solution and Fatigued in Laboratory Air (1 Hz, R=0.1) with Exfoliation Corrosion Shown on Left Side of Micrograph**

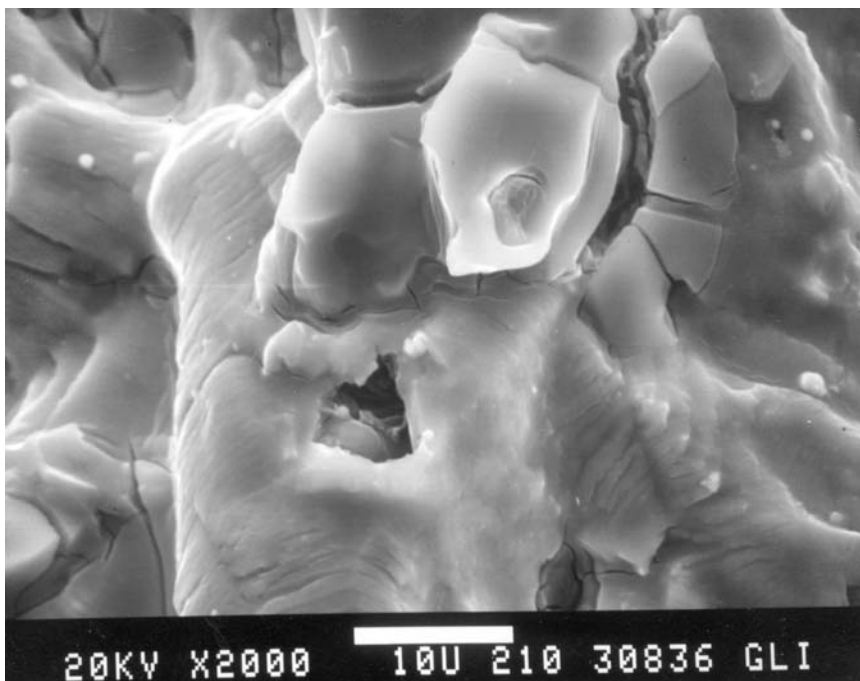
**Figure 37. Detail of Area A in Figure 36 Showing Characteristic Mud Cracking**

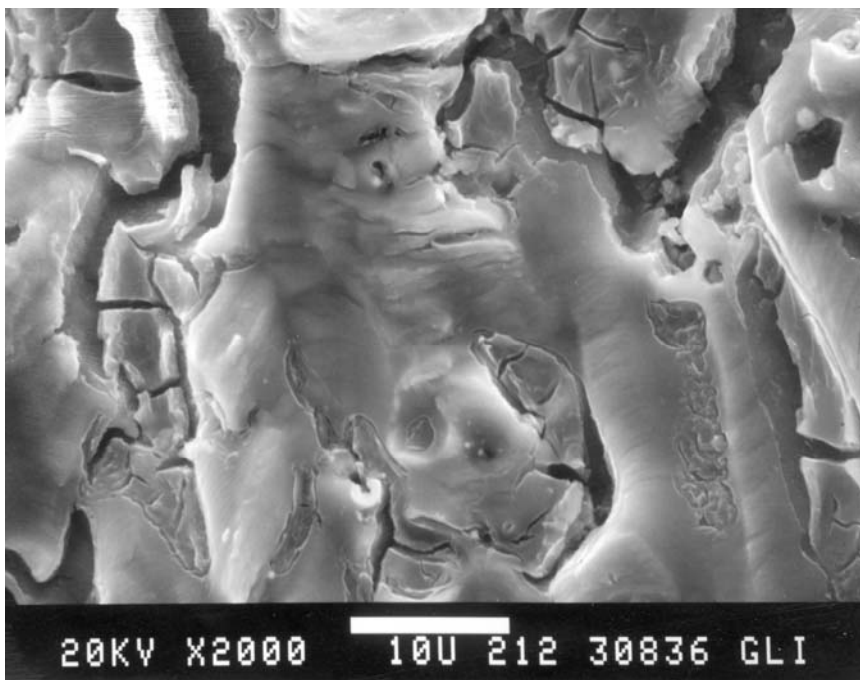
**Figure 39. Detail of Area A in Figure 38 Showing Characteristic Mud Cracking**

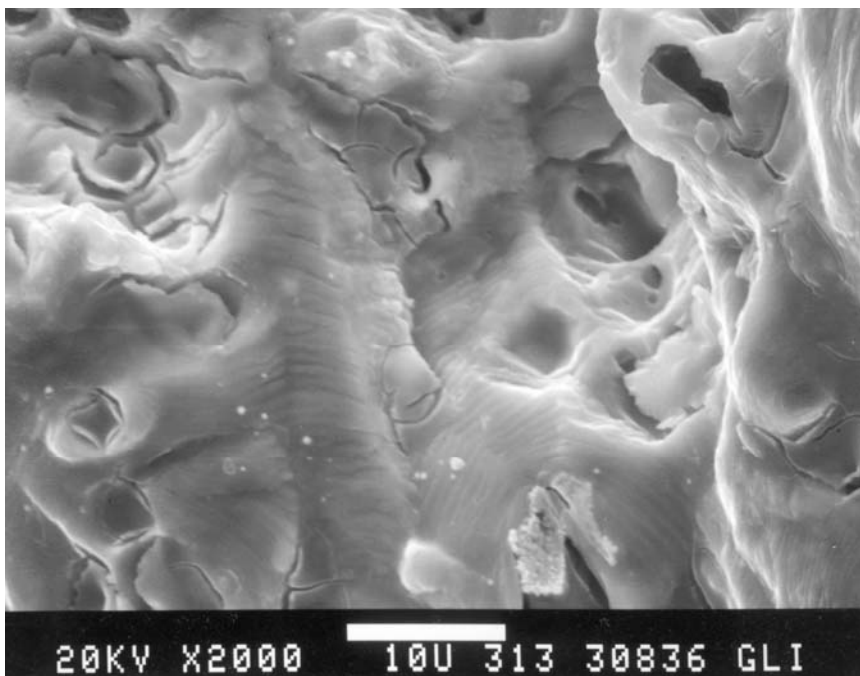
**Figure 41. Detail of Area A in Figure 40 Showing Characteristic Mud Cracking and Vague Fatigue Striations**

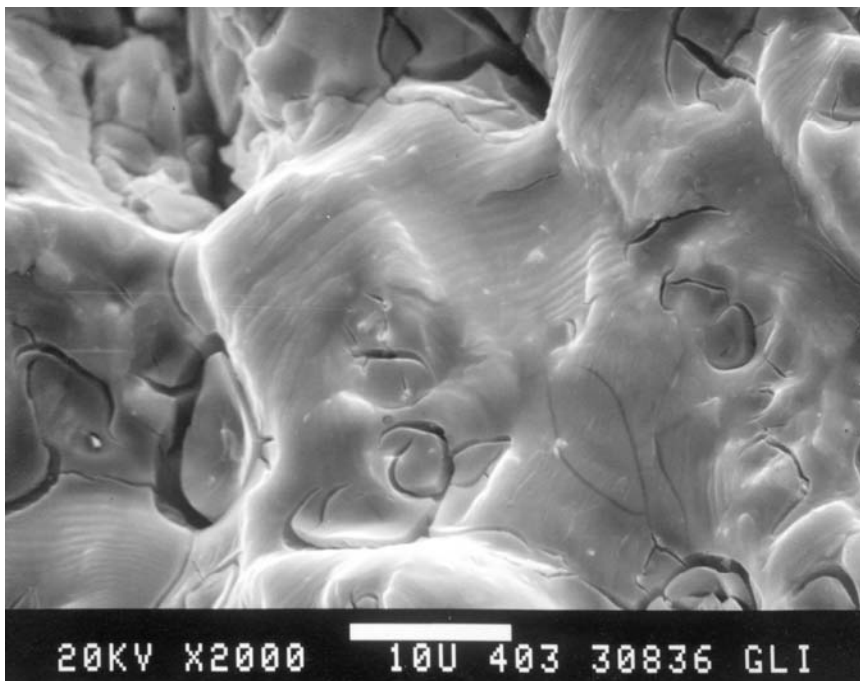
**Figure 43. Detail of Area A in Figure 42 Showing Characteristic Mud Cracking and Vague Fatigue Striations**

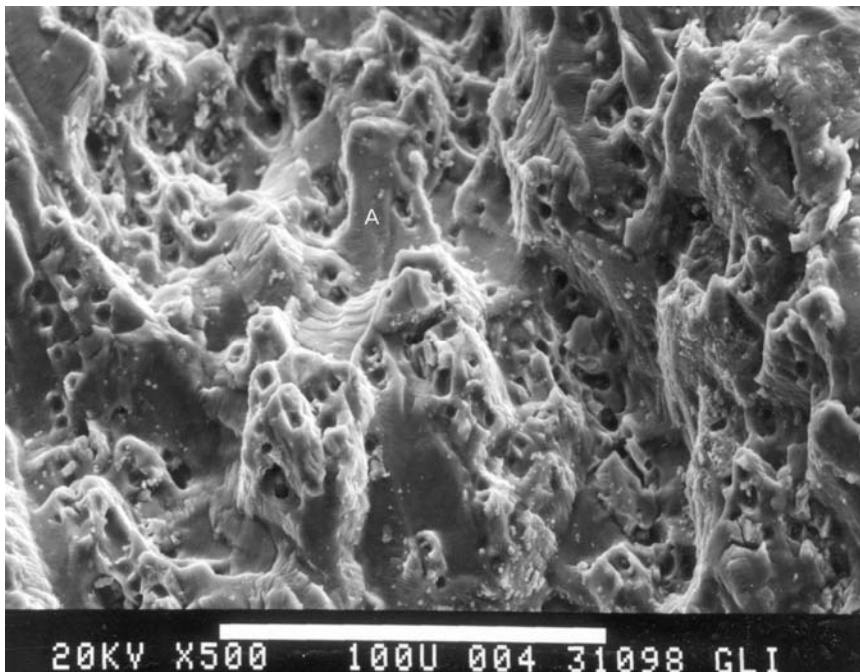
**Figure 44. SEM of Aluminum Alloy 2024-T3 Precharged with Hydrogen and Fatigue Laboratory Air (1 Hz, R=0.1); Near the Specimen Surface**

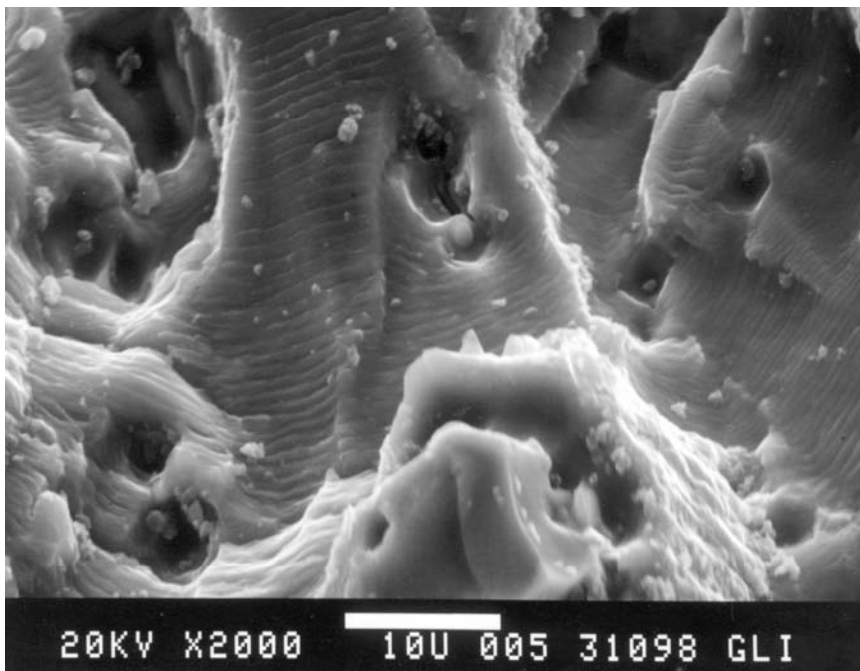
**Figure 45. Detail of Area A in Figure 44 Showing a Mixture of Areas with Fatigue Striations and Ductile Rupture**

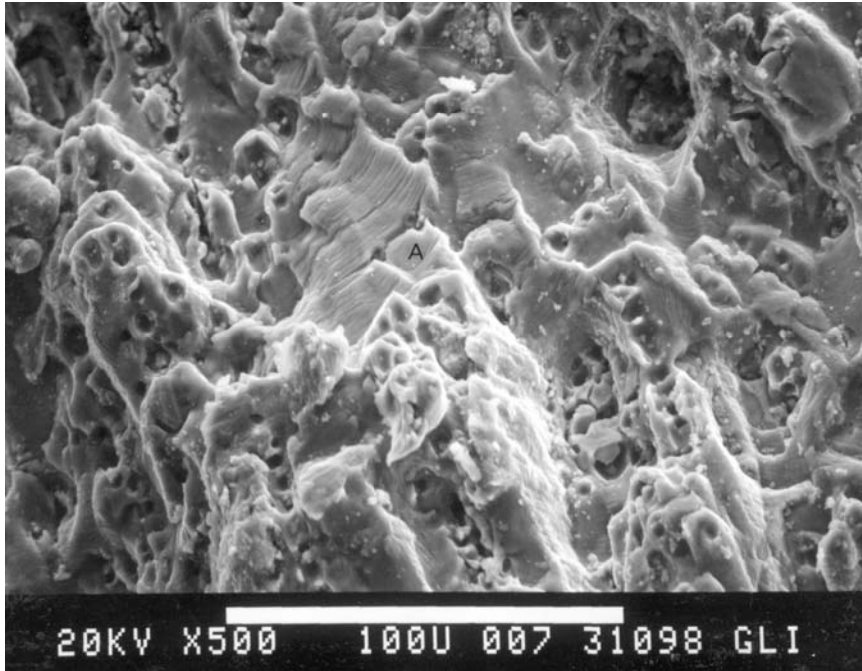
**Figure 46. SEM of Aluminum Alloy 2024-T3 Precharged with Hydrogen and Fatigue in Laboratory Air (1 Hz, R=0.1); Away from Specimen Surface**

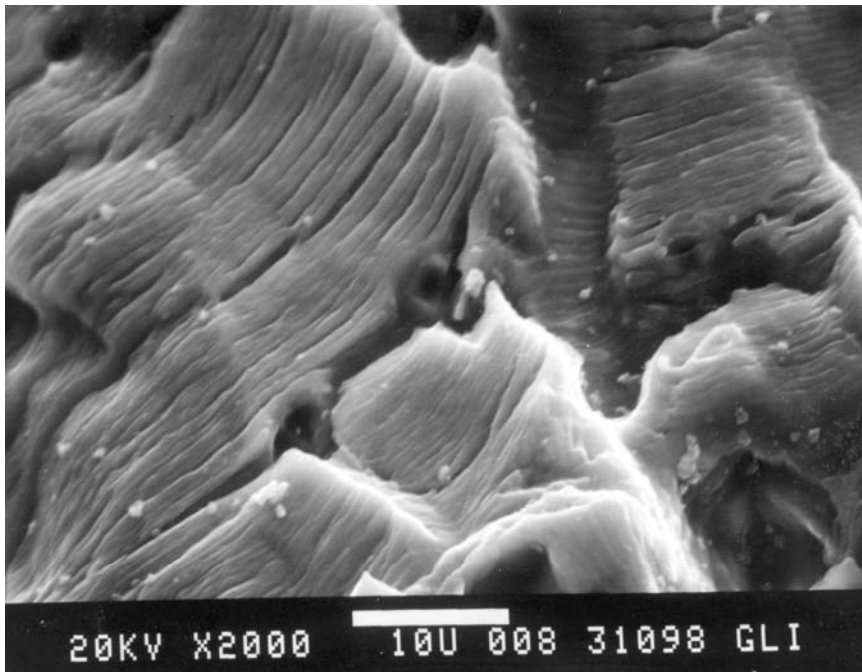
**Figure 47. Detail of Area A in Figure 46 Showing Brittle Fatigue Arrest Markings**

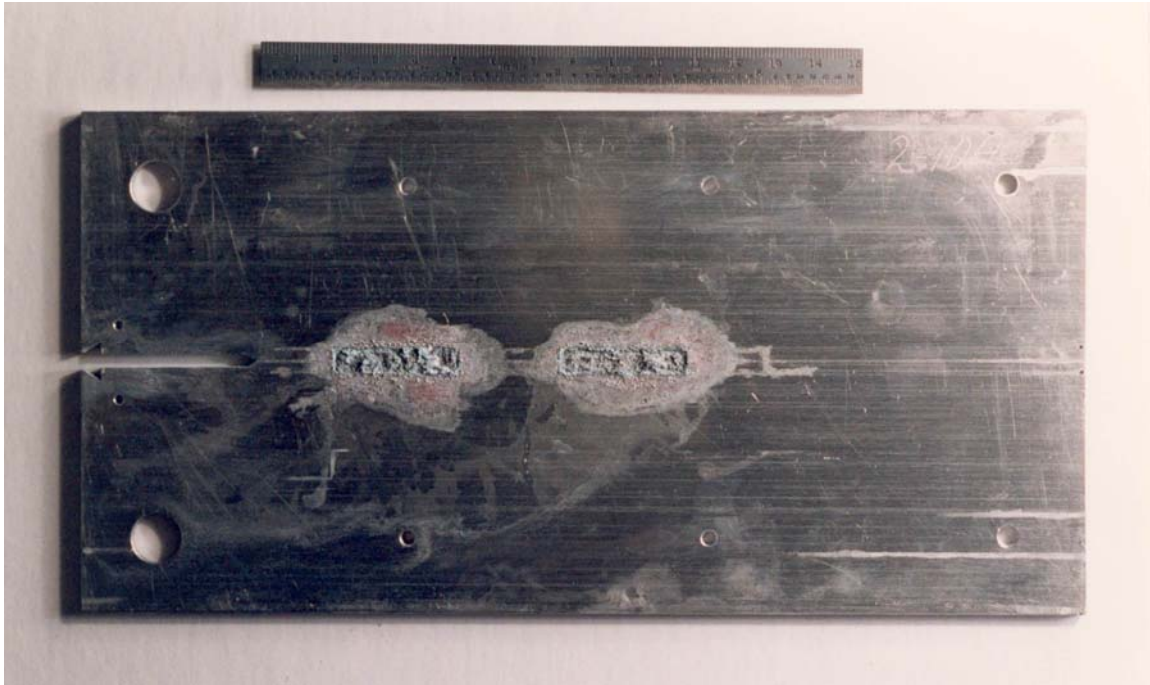
**Figure 48. Modified CT Specimen with Corroded Areas in Crack Path; Corroded Areas Created via Two-day Exposure to EXCO Solution**

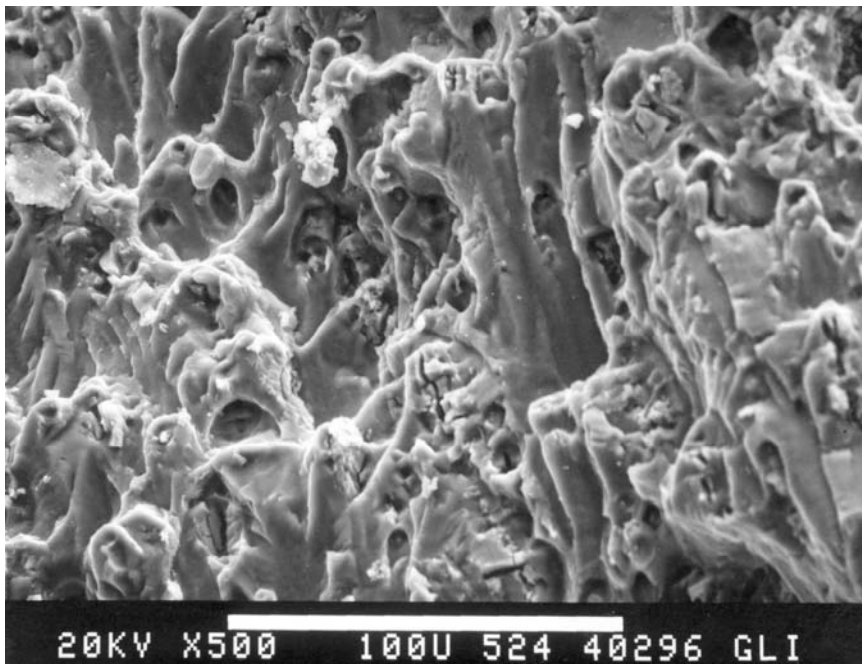
**Figure 49. SEM of Aluminum Alloy 7075-T6 Precorroded in the EXCO Solution for 2 Days and Fatigued in Laboratory Air (1 Hz, R=0.1)**

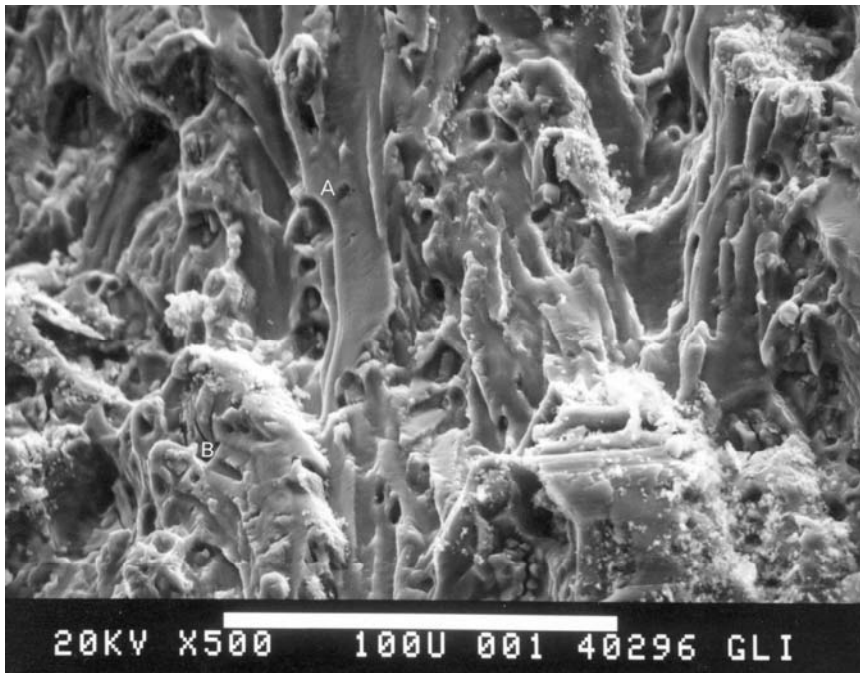
**Figure 53. SEM of Aluminum Alloy 7075-T6 Precharged with Hydrogen and Fatigued in Laboratory Air (1 Hz, R=0.1)**

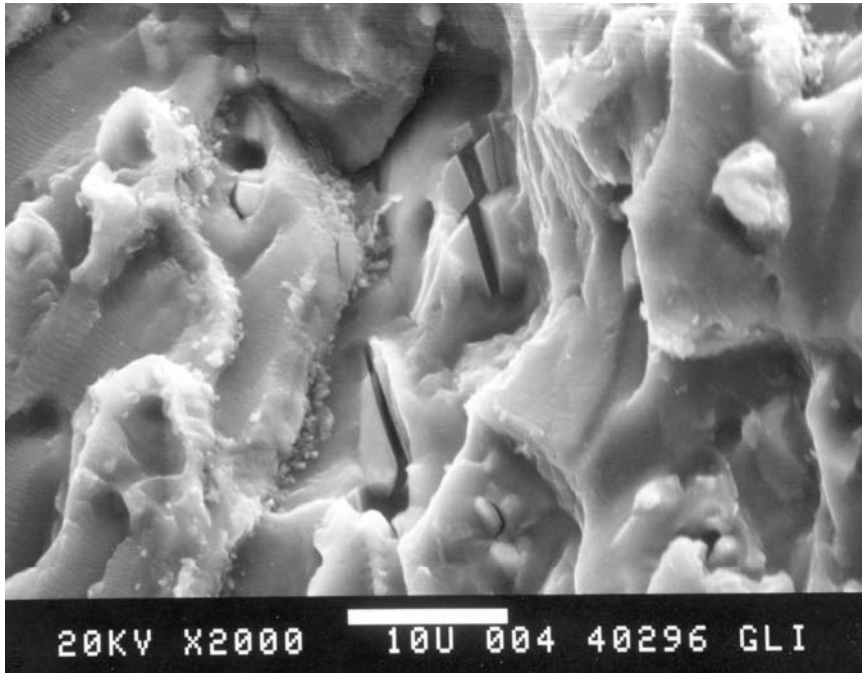
**Figure 55. Detail of Area B in Figure 53 Showing Brittle Secondary Cracking**

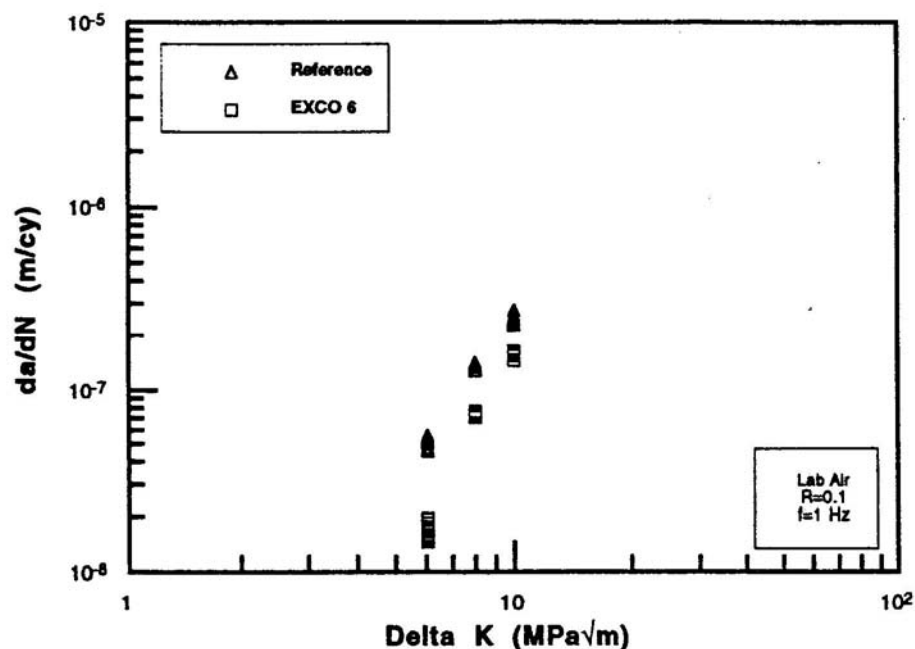
**Figure 56. Fatigue Crack Growth Data for Aluminum Alloy 7075-T6 CT Specimens in As Received Condition and Precorroded in the EXCO Solution for 2 Days; Fatigue cracked at Three(3) Constant  $\Delta K$  Levels**

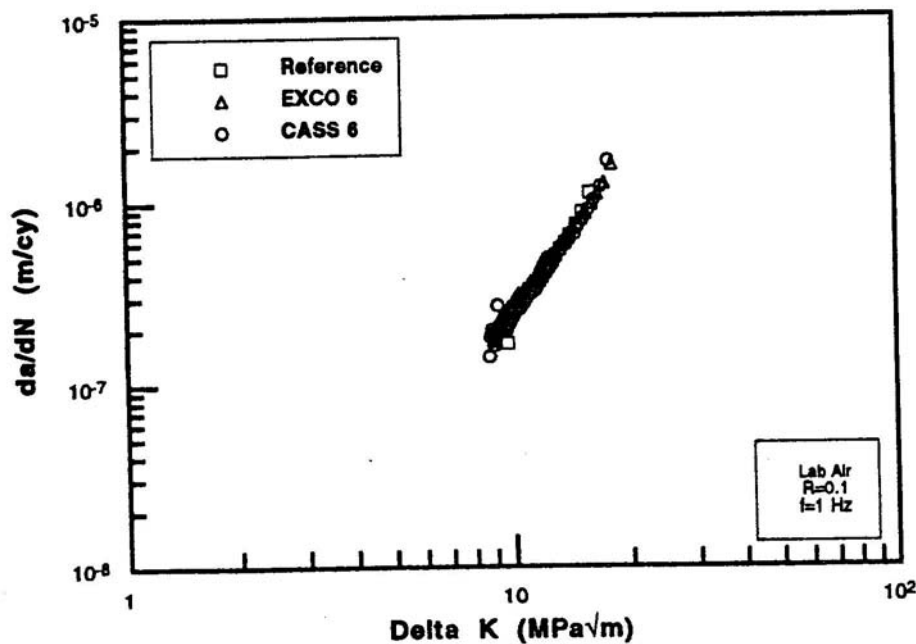
Figure 57. Fatigue Crack Growth Data for Aluminum Alloy 7075-T6 CT Specimens with Different Degrees of Corrosion
